# Belzona SuperWrap II System Saves 120k

Application: VPF-Valves, Pipes and Fittings

Substrate: Cast Iron

Products: Belzona 1982 (SuperWrap II), Belzona 4141 (Magma-Build)

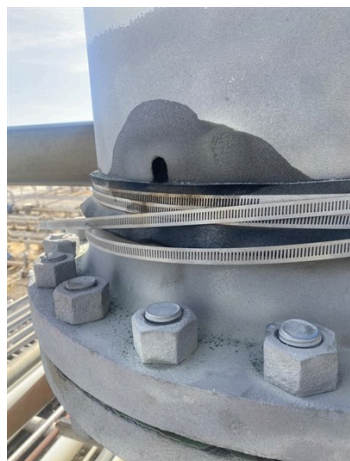
The customer had a clamp previously put on a hole in the condensate line. The clamp started leaking and they were going to replace them at this time.

Line clamp leaking.

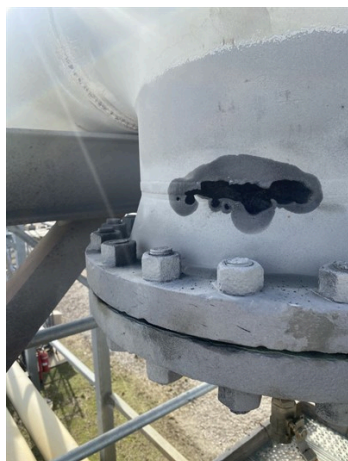
Clamp removed and vapor blaster used.

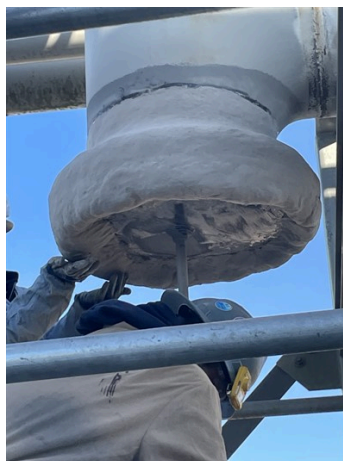
Encapsulation of entire head.

Belzona 4141 was used to encapsulate the holes and then Belzona SuperWrap II system (with Belzona 1982 resin) was used to provide structural integrity to the asset.

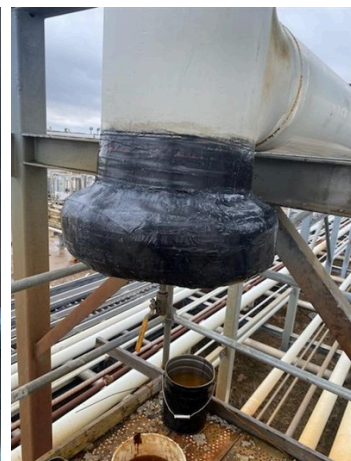
Finalized SuperWrap II application.
