# Belzona Protects Acid Barge Drip Pans

ID: 9082

Industry: *Marine*  
Application: *TCC-Tanks and Chemical Containment Areas*

Products: *Belzona 4301 (Magma CR1 Hi-Build), Belzona 4311 (Magma CR1)*

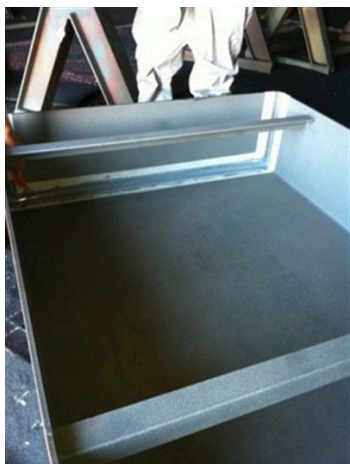
*Customer was experiencing corrosion in their unlined drip pans.*

Surface preparation drip pan 1

Client was replacing their acid drip pans every few years. Acid remnants would sit in the pans exposed to atmosphere and corrode the bottom.

Grit basted the interior surface. Applied 4301 to fillet the weld seams. Then applied 4311 to the entire interior.

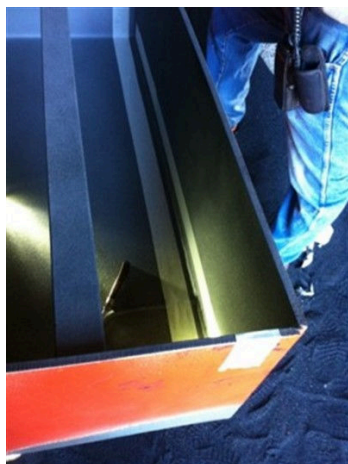
Surface preparation drip pan 2

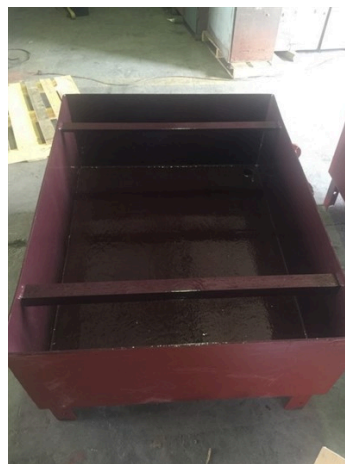
Product application process

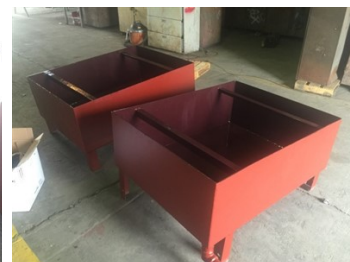
Application completed.

Coating with Belzona dramatically extended the life of the pans, saving the customer money not having to replace them every few years.
