Belzona Provides Anti-Cavitation Resistance to Drive Shaft

ID: 9116

Industry: *Marine*
Application: *SOS-Ships and Offshore Structures*

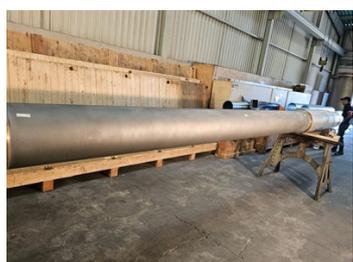
1.) Driveshaft after grit blasting

This application was carried out in accordance with adapted versions of system leaflets SOS-6 & SOS-2. First, the drive shaft was grit blasted to SA2.5, achieving a 75-micron profile. After surface preparation, any required areas were rebuilt with Belzona 1311 before 2 coats of Belzona 1341 were applied. Finally, Belzona 2941 conditioner was applied before 2 coats of Belzona 2141.

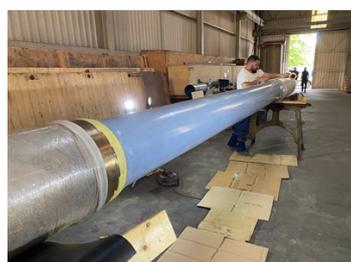
2.) 2 coats of Belzona 1341 applied

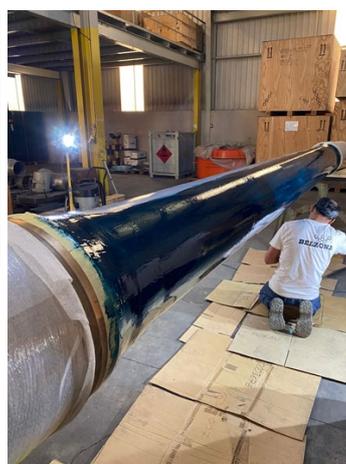
3.) 1st coat of Belzona 2141 being applied

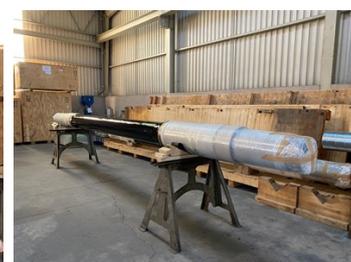
4.) Final application - 2 coats of Belzona 2141
