# BELZONA REPAIRS AND PROTECTS WATER TREATMENT PLANT

**Industry:** Power  
**Application:** TCC-Tanks and Chemical Containment Areas  
**Substrate:** Concrete and a failed competitor coating  
**Products:** \* Belzona® 4131 (Magma Screed) ,  
\* Belzona® 4181 (Magma AR Screed) ,  
\* Belzona® 4311 (Magma CR-1) ,

**Customer Location:** Nuclear Power Plant, Lancashire – UK  
**Application Date:** March 2007

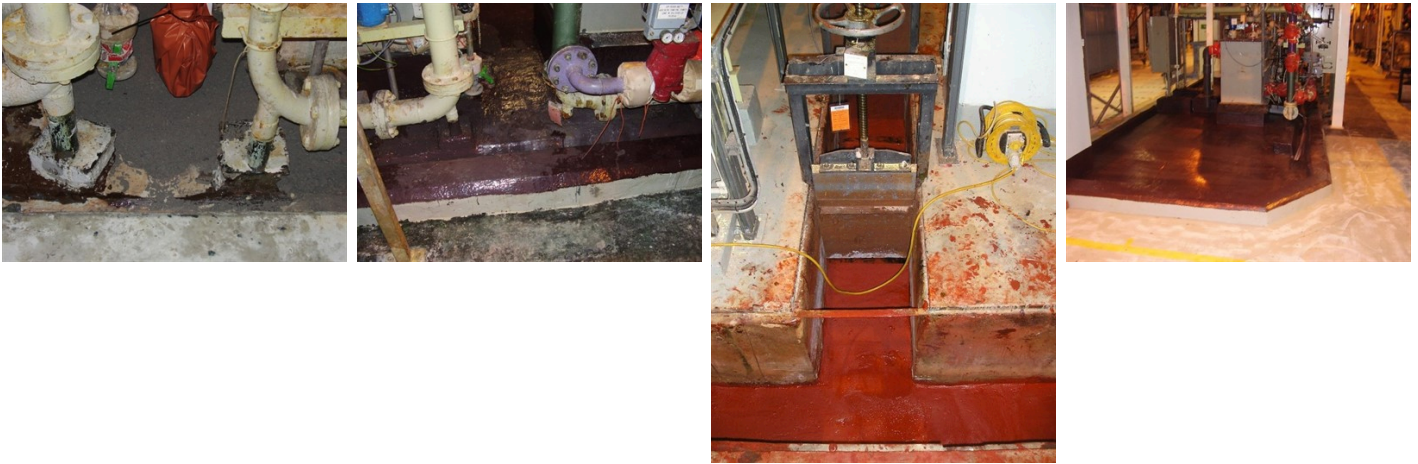
The concrete bunds and channel were badly deteriorated from the acid. Previously applied competitor coating had failed to protect the concrete substrate.

- \* Substrate rebuilt using Belzona® 4131 ,
- \* Protection provided by Belzona® 4311 coating ,
- \* Channels rebuilt and lined with Belzona® 4181 ,
- \* Completed application back in service ,

The customer was impressed that this permanent repair was completed in five days. The first application was recently inspected after eight months because of an acid spillage during maintenance and the Belzona was still as good as the day it was first applied. Belzona® 4311 was chosen because the bund is frequently exposed to spillage and has proven to withstand the chemicals. Belzona® 4181 allowed rebuilding and protection of the channels whilst providing erosion resistance to the flow of acid.
