# Belzona Protects Pipelines on Offshore Platform

ID: 9166

Industry: Marine  
Application: VPF-Valves, Pipes and Fittings  
Substrate: Carbon steel  
Products: Belzona 1331

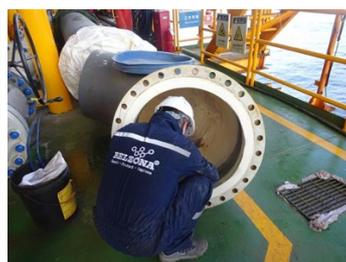
Belzona 1331 is being sprayed inside the pipeline

Application was carried out with an adapted version of Belzona System Leaflet VPF-02. The inner linings of pipes and elbows are applied with Belzona products using spraying guns and brushes.

The main challenge of this project lies in the spraying process within the pipeline, given the diverse inner diameters of the pipes. Each type necessitates adjusting the output pressure of the sprayer to regulate the flow rate of the spraying material. Additionally, controlling the rotating nozzle to traverse the pipe at a consistent speed is crucial. This, coupled with the need to manage the spray film thickness, makes the project much more difficult.

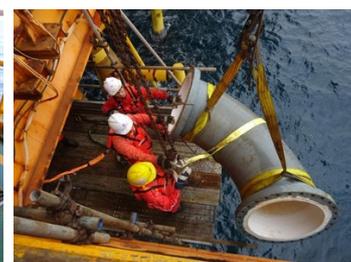
Spraying application completed
