Belzona Repairs and Protects Circulating Water Pipelines

ID: 9170

Application: VPF-Valves, Pipes and Fittings

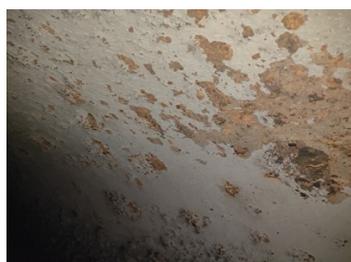
The circulating water pipeline has not been replaced in over 30 years since the factory was built and leakage problems often occurred due to corrosion. The customer's initial measure was to use wooden wedges to seal the leakage points and then weld steel plates around them. However, this approach could not address the fundamental problem.

Before Repair

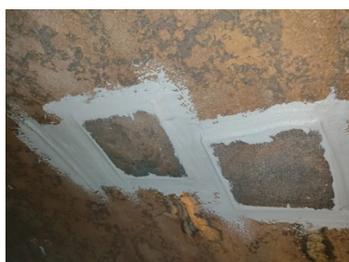
Use Belzona 1111 to repair pipe leakage

First, grit blast the pipeline and use Belzona 1111 to repair pipe leaks. The wooden wedges at the original leakage points are then sawed off and bonded with steel plates. There were more than 200 leakage points. Finally, apply two coats of Belzona 5811, with an average thickness of about 600µm.

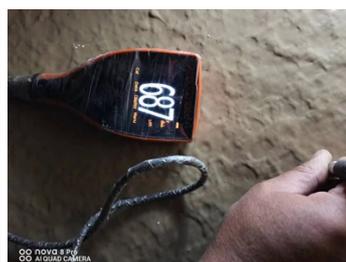
DFT test after applying two coats of Belzona 5811

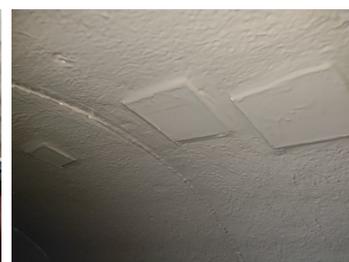
Application completed
