# Belzona delivers on awkward roof

ID: 9171

Application: RPA-Roof Problem Areas

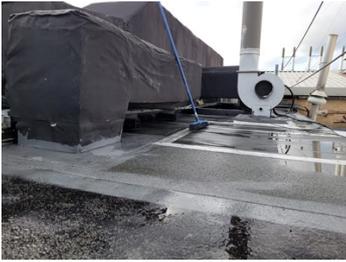
Bolted assets and standing water

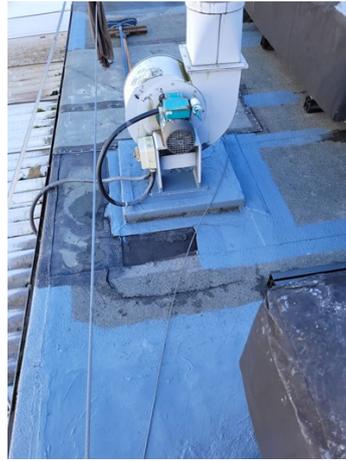
Geometric challenges overcome using Belzona 3000 series

The roof was thoroughly cleaned prior to applying conditioner to some areas. After this, 2 x coats of the Belzona 3131 (WG membrane), along with the appropriate Belzona 9351 (Reinforcing Tape).

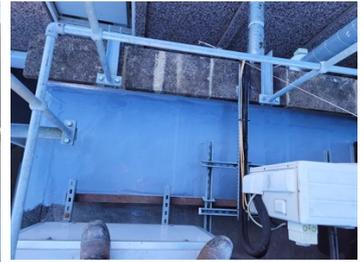
Fully encapsulated in a short time with little difficulty
