# Belzona Coats Aging Carbon Steel Pipeline

Industry: Water / Wastewater  
Application: VPF-Valves, Pipes and Fittings  
Substrate: Carbon steel  
Products: Belzona 5821

Customer Location: New Zealand  
Application Date: 2023

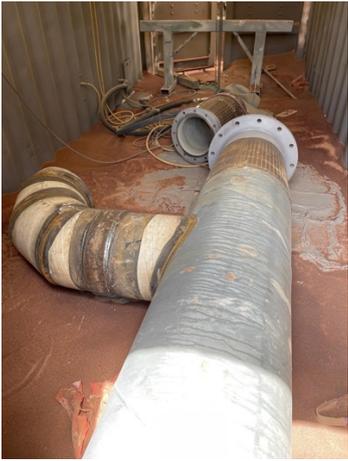
The carbon steel pipes that needed to be coated

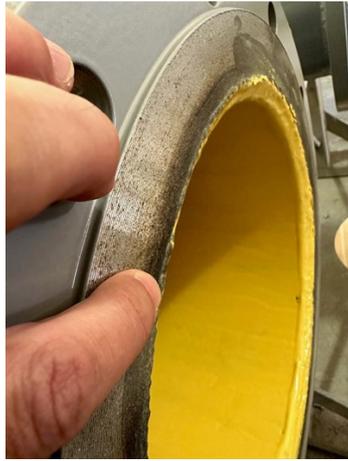
Damage to aging pipe

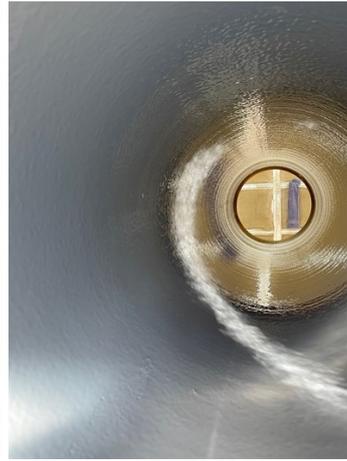
Internal coating of Belzona 5821 on pipe

We use spin blasting equipment with A grade garnet to gain the best internal profile as possible and then use spin spray equipment attached to the latest WIWA 71:1 pump equipment with an inline heater.

We have a computer controlled device that works on surface area to be coated, volume of material delivery from the pump, and diameter of the pipe to adjust the pull rate to ensure a high degree of accuracy for the 5821 delivery concerning uniform aesthetics and final DFT of the lining. Belzona 5821 is a ceramic-filled epoxy system that is reasonably cost-effective for large surface areas given that it is a relatively thin film coating system and is applied in two coats. The 5821 also has very good abrasion resistance yet is still a sprayable formulation. The 5821 is applied via spin spray for spools of internal diameters ranging from 76mm – 1m. All spools over 1m in diameter are sprayed by hand.

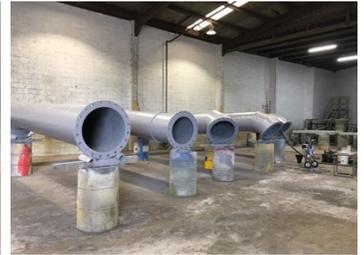
Two coats of Belzona 5821 applied onto external pipes
