Belzona Coats Aging Carbon Steel Pipeline

ID: 9196

Industry: Water / Wastewater
Application: VPF-Valves, Pipes and Fittings
Substrate: Carbon steel
Products: Belzona 5821

Customer Location: New Zealand
Application Date: 2023

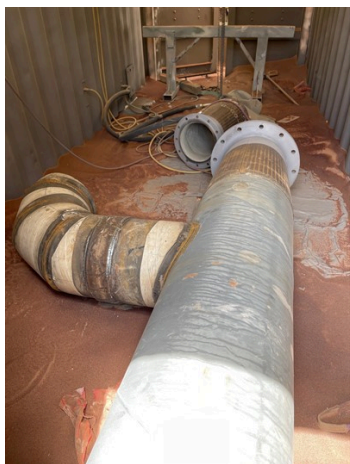
The carbon steel pipes that needed to be coated

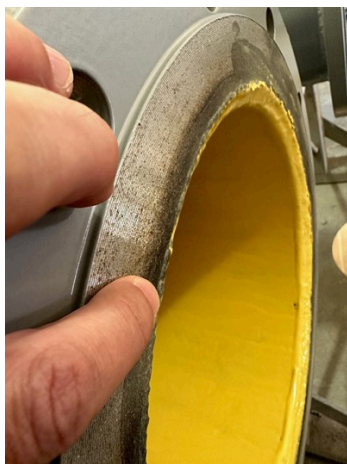
Damage to aging pipe

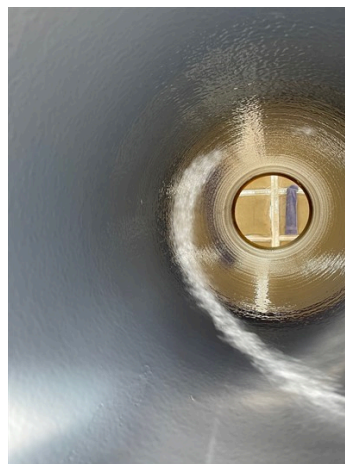
Internal coating of Belzona 5821 on pipe

We use spin blasting equipment with A grade garnet to gain the best internal profile as possible and then use spin spray equipment attached to the latest WIWA 71:1 pump equipment with an inline heater.

We have a computer controlled device that works on surface area to be coated, volume of material delivery from the pump, and diameter of the pipe to adjust the pull rate to ensure a high degree of accuracy for the 5821 delivery concerning uniform aesthetics and final DFT of the lining. Belzona 5821 is a ceramic-filled epoxy system that is reasonably cost-effective for large surface areas given that it is a relatively thin film coating system and is applied in two coats. The 5821 also has very good abrasion resistance yet is still a sprayable formulation. The 5821 is applied via spin spray for spools of internal diameters ranging from 76mm – 1m. All spools over 1m in diameter are sprayed by hand.

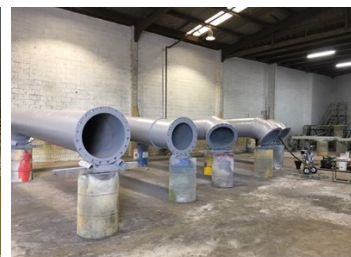
Two coats of Belzona 5821 applied onto external pipes
