Reinforcement of an Ammonia Tank using Belzona SW2.

ID: 9215

Customer Location: St Nazaire, France

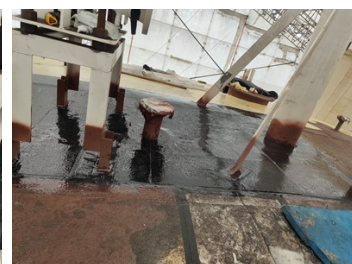
Reinforcement application completed prior to the application of Belzona 5831 LT.

To restore the damaged areas, we first needed to pit-fill to the exact profile of the original roof using Belzona 1121. Then, to reinforce the areas in need of repair we conducted SuperWrap II patch repairs. Finally, to provide anti-corrosion assurance we applied corrosion barrier coating, Belzona 5831LT.
