Handrail bonding on offshore deck

ID: 9253

Industry: Oil & Gas
Application: GSS-Gaskets, Seals and Shims
Substrate: Carbon steel
Products: Belzona 1161 (Super UW-Metal), Belzona 5811 (Immersion Grade), Belzona 7311

Customer Location: Offshore
Application Date: July 2023

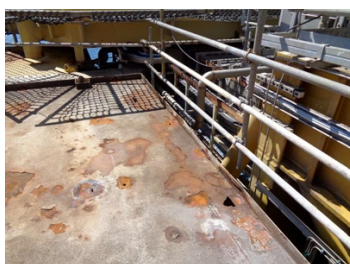
Deck before application

A new handrail was designed on an offshore loading deck just above critical lower deck. Because there were some holes in the deck due to corrosion, welding new plates was not clients first choice. A very strong bonding was required and had to be designed and calculated. Also the flexibility of the Belzona 7311 was preferable because large containers could impact into the handrail.

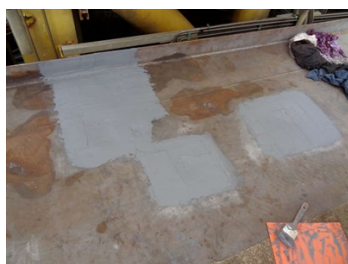
Fixing the holes with Belzona 1161 and re-inforcement sheets

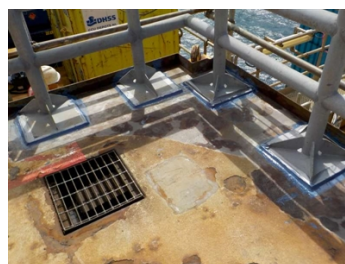
Bonding the small plates with Belzona 7311.
The bigger plate was bonded with Belzona 7311 and injected with Belzona 5811.

The bigger plate of 5000[mm] x 1000[mm] was bonded with Belzona 7311 and after curing injected with Belzona 5811. Separate parts of the handrail were bonded with the Belzona 7311 completely.

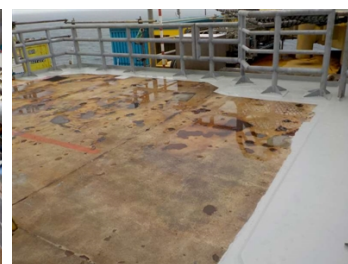
Application ready to be top coated.
