Handrail bonding on offshore deck

ID: 9253

Industry: Oil & Gas
Application: GSS-Gaskets, Seals and Shims
Substrate: Carbon steel
Products: Belzona 1161 (Super UW-Metal), Belzona 5811 (Immersion Grade), Belzona 7311

Customer Location: Offshore
Application Date: July 2023

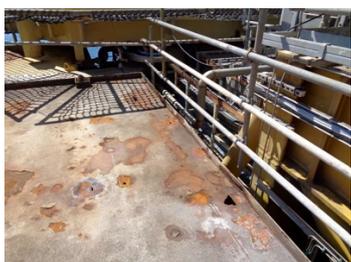
Deck before application

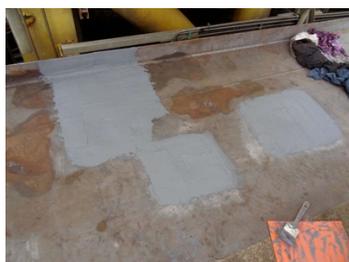
Fixing the holes with Belzona 1161 and re-inforcement sheets

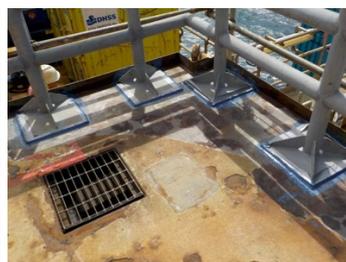
Bonding the small plates with Belzona 7311.
The bigger plate was bonded with Belzona 7311 and injected with Belzona 5811.

The bigger plate of 5000[mm] x 1000[mm] was bonded with Belzona 7311 and after curing injected with Belzona 5811. Separate parts of the handrail were bonded with the Belzona 7311 completely.

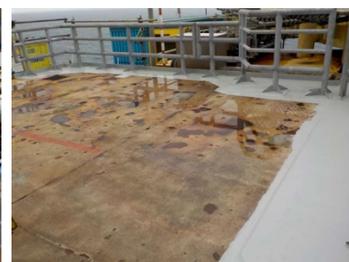
Application ready to be top coated.
