Belzona 9811 Alumina Tiles Extend Separator Lifespan Fourfold

Industry: Pulp & Paper

Application: SHM-Solids Handling Machinery

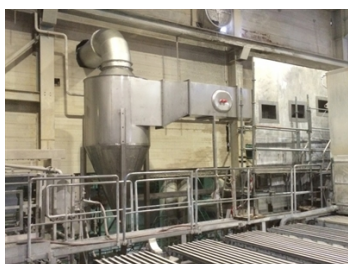
A wider view of the separator

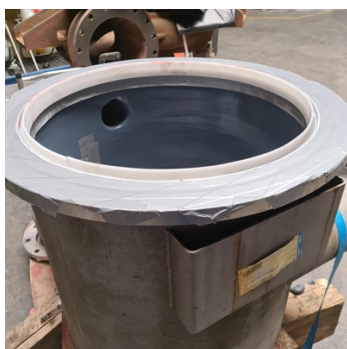
Mid-application

In response, we incorporated the use of Belzona 9811 Alumina Tiles, significantly extending the protection lifespan by four times compared to Belzona 1812 and Belzona 1321. Despite the enhanced durability, the service cost remains similar to the previous solutions. To implement this improvement, we used Belzona 1311 (8KG), Belzona 1321 (1.5KG), Belzona 9811 (1m²) & Belzona 1812 (8KG). The customer had contemplated replacing the separator technology due to the inadequacy of Belzona 1812 and Belzona 1321 in terms of durability and cost-effectiveness.

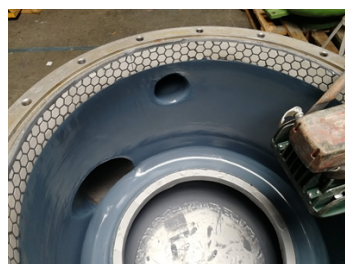
The completed application

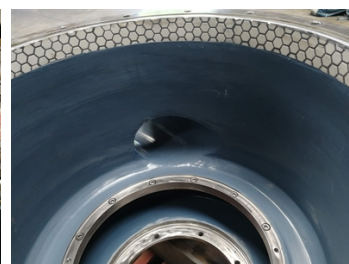
The completed application
