Belzona 9811 Alumina Tiles Extend Separator Lifespan Fourfold

Industry: *Pulp & Paper*

Application: *SHM-Solids Handling Machinery*

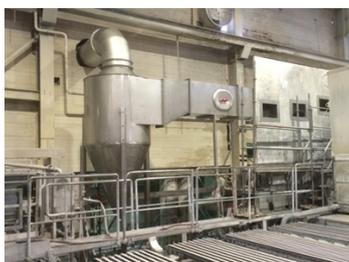
A wider view of the separator

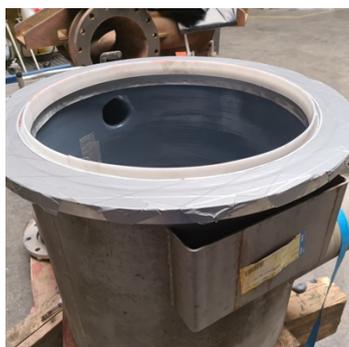
Mid-application

In response, we incorporated the use of Belzona 9811 Alumina Tiles, significantly extending the protection lifespan by four times compared to Belzona 1812 and Belzona 1321. Despite the enhanced durability, the service cost remains similar to the previous solutions. To implement this improvement, we used Belzona 1311 (8KG), Belzona 1321 (1.5KG), Belzona 9811 (1m²) & Belzona 1812 (8KG). The customer had contemplated replacing the separator technology due to the inadequacy of Belzona 1812 and Belzona 1321 in terms of durability and cost-effectiveness.

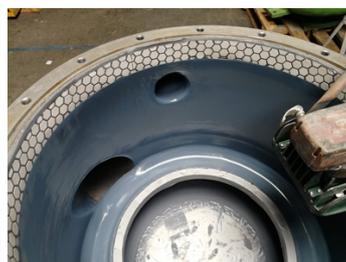
The completed application

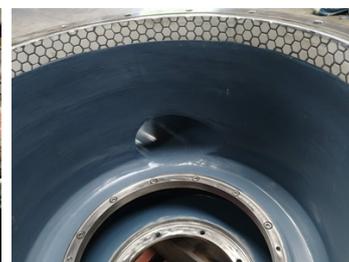
The completed application
