Belzona 9811 Alumina Tiles Extend Separator Lifespan Fourfold

Industry: *Pulp & Paper*

Application: *SHM-Solids Handling Machinery*

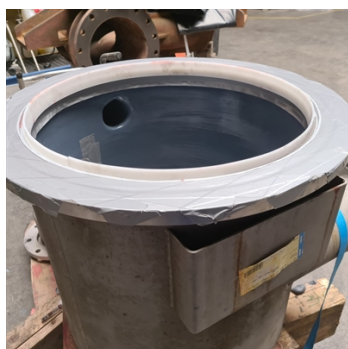
Mid-application

In response, we incorporated the use of Belzona 9811 Alumina Tiles, significantly extending the protection lifespan by four times compared to Belzona 1812 and Belzona 1321. Despite the enhanced durability, the service cost remains similar to the previous solutions. To implement this improvement, we used Belzona 1311 (8KG), Belzona 1321 (1.5KG), Belzona 9811 (1m²) & Belzona 1812 (8KG). The customer had contemplated replacing the separator technology due to the inadequacy of Belzona 1812 and Belzona 1321 in terms of durability and cost-effectiveness.

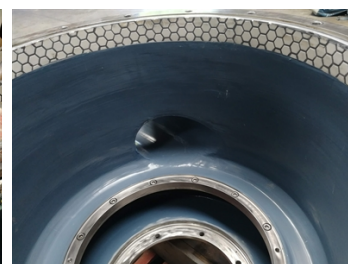
The completed application
