# 350,000 Tin Roof Bolts Coated with Belzona Flexible Membrane

Application: *RPA-Roof Problem Areas*

*Water was leaking from the anchoring bolt joints and overlapping joint area of a cast house pot room overhead tin roof.*

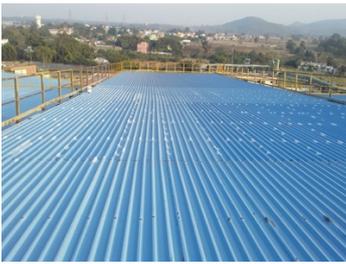
Tin roof required a repair on anchor bolts and joints to prevent water ingress

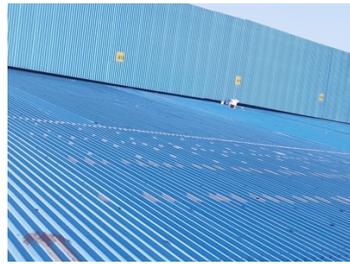
The repair on the roof in progress

Firstly, the colour was stripped from the tin roof and the surface was thoroughly cleaned using a wire brush.

Belzona 3921 (GSC Surface Conditioner) was applied to the application area and allowed to dry. Later, Belzona 9311 (Reinforcement Sheet) was placed around the anchor bolt and joint area prior to the application of Belzona 3111 (Flexible Membrane.)

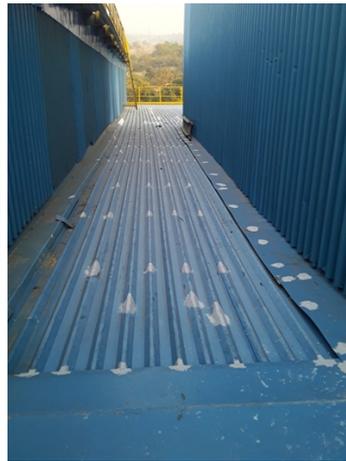
The tin roof bolts sealed with Belzona 3111

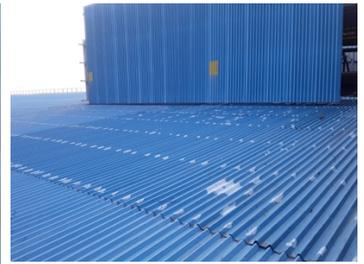
The tin roof bolts sealed with Belzona 3111 to prevent water ingress
