Protection of Sea Water Pipe Pieces with Belzona 5821

ID: 9300

Industry: Marine
Application: VPF-Valves, Pipes and Fittings
Substrate: Carbon steel
Products: Belzona 5821

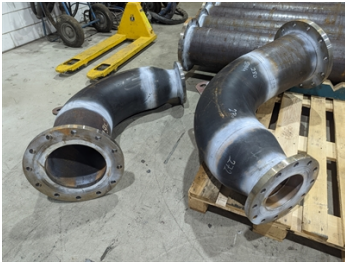
First set of Pipe Bends ready to be coated

On completion of adequate surface preparation, Belzona 5821 a ceramic-filled epoxy system was applied. The system was applied by hand in two coats. This solution is cost-effective for large surface areas given the relatively thin target thickness.

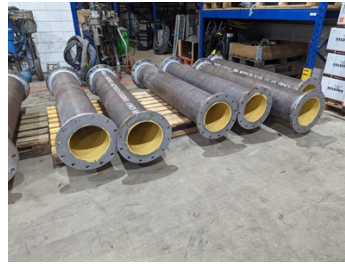
First coat of Belzona 5821 in yellow applied to pipe straights

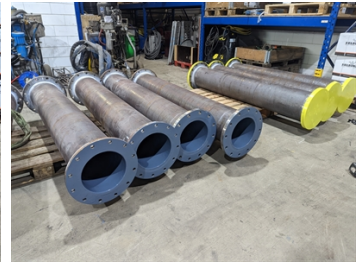
Second coat of Belzona 5821 in slate grey applied
