Protection of Sea Water Pipe Pieces with Belzona 5821

ID: 9300

Industry: Marine
Application: VPF-Valves, Pipes and Fittings
Substrate: Carbon steel
Products: Belzona 5821

Customer Location: The Netherlands
Application Date: November 2022

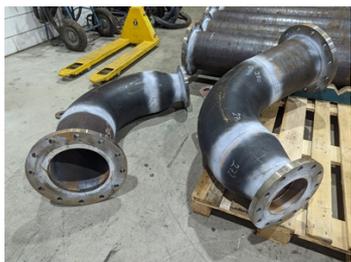
First set of Pipe Bends ready to be coated

On completion of adequate surface preparation, Belzona 5821 a ceramic-filled epoxy system was applied. The system was applied by hand in two coats. This solution is cost-effective for large surface areas given the relatively thin target thickness.

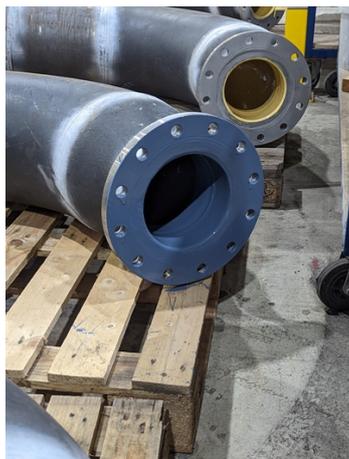
Internals coated with Belzona 5821

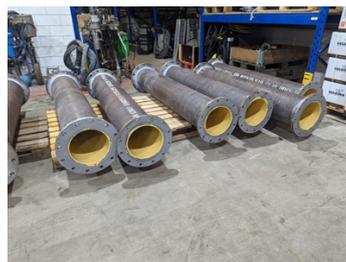
First coat of Belzona 5821 in yellow applied to pipe straights

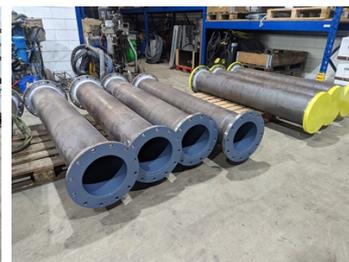
Second coat of Belzona 5821 in slate grey applied
