# Belzona Protects New Pumps with Anti-corrosion Coating with Drinking Water Safety Certificate

ID: 9311

Industry: Fluid Flow  
Application: CEP-Centrifugal Pumps  
Substrate: Cast Iron  
Products: Belzona 5811DW2 (DW Immersion Grade)

Customer Location: Jiangsu, China 中国  
Application Date: May 2017

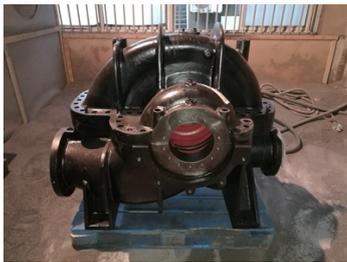
Before application

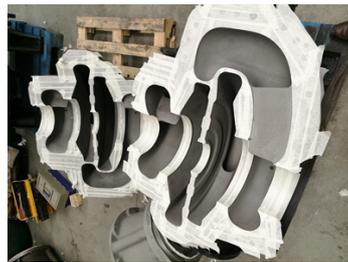
After surface preparation

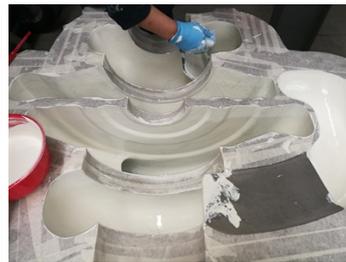
During application of Belzona 5811 DW2

Application was carried out in accordance with Belzona Know-How System Leaflets CEP-03 and the IFU of Product.

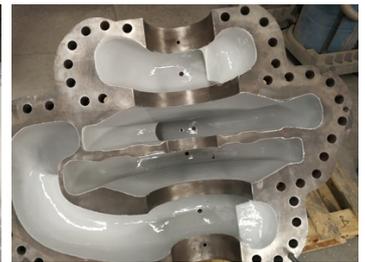
Application completed
