# Belzona Protects New Pumps with Anti-corrosion Coating with Drinking Water Safety Certificate

ID: 9311

Industry: Fluid Flow  
Application: CEP-Centrifugal Pumps  
Substrate: Cast Iron  
Products: Belzona 5811DW2 (DW Immersion Grade)

Customer Location: Jiangsu, China 中国  
Application Date: May 2017

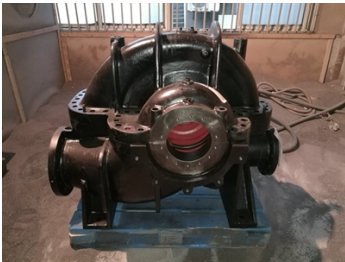
Before application

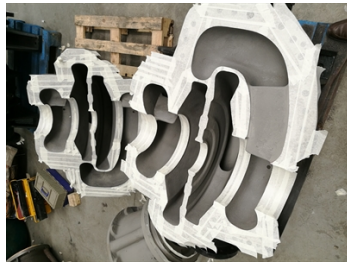
After surface preparation

Application was carried out in accordance with Belzona Know-How System Leaflets CEP-03 and the IFU of Product.

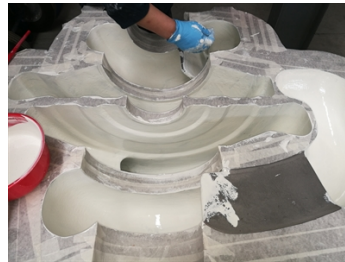
During application of Belzona 5811 DW2

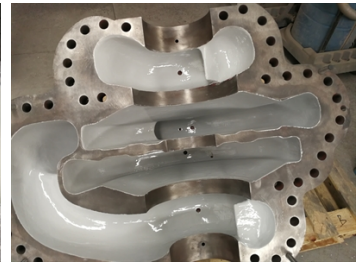
Application completed
