Belzona Energy-saving Coatings Improve Pump Efficiency

ID: 9312

Industry: Fluid Flow
Application: CEP-Centrifugal Pumps
Substrate: Cast Iron
Products: Belzona 1341 (Supermetalglide)

Customer Location: Jiangsu, China
Application Date: May 2019

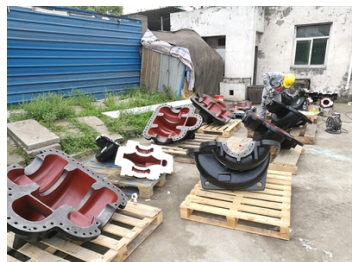
Before application

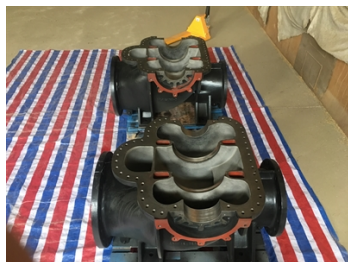
After surface preparation

Application was carried out in accordance with Belzona System leaflet CEP-10.

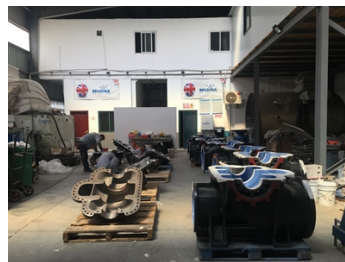
During application of Belzona 1341

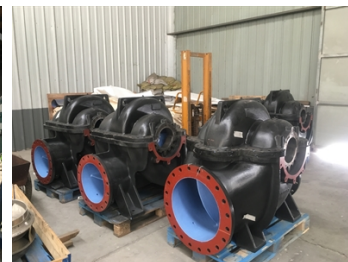
Application completed

The pump efficiency of the new pump was tested before leaving the factory and it was found that it did not reach the target value. Traditional methods of smoothing the substrate surface to reduce fluid resistance and enhance pump efficiency have had limited success. The customer chose to apply Belzona energy-saving and efficiency-enhancing coating to the overall internal flow surface of the pump casing, and the pump efficiency was improved. The effect is significant. The test of pump efficiency before and after the coating applied showed that pump efficiency increased by more than 3%, far exceeding the pump efficiency target value required for delivery and far exceeding customer expectations.
