Belzona Provides New Pumps with Anti-corrosion Protection

ID: 9313

Industry: *Fluid Flow*
Application: *CEP-Centrifugal Pumps*
Substrate: *Cast Iron*
Products: *Belzona 5821*

Customer Location: *Jiangsu, China*
Application Date: *August 2022*

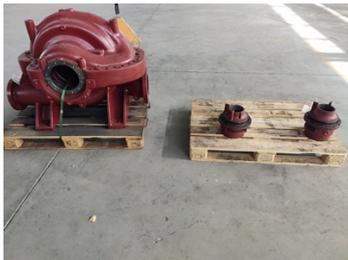
Before application

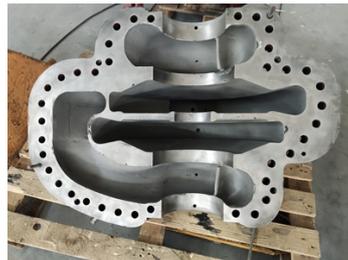
After surface preparation

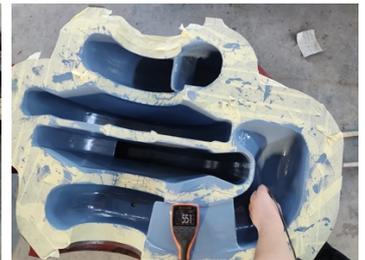
DFT after cured
