Belzona Provides New Pumps with Anti-corrosion Protection

ID: 9313

Industry: Fluid Flow
Application: CEP-Centrifugal Pumps
Substrate: Cast Iron
Products: Belzona 5821

Customer Location: Jiangsu, China
Application Date: August 2022

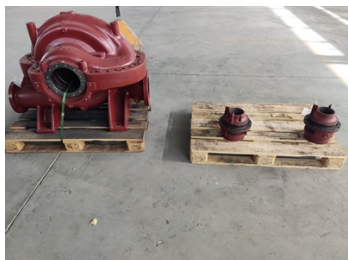
Before application

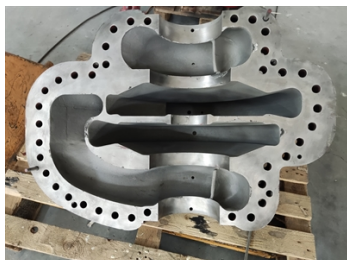
After surface preparation

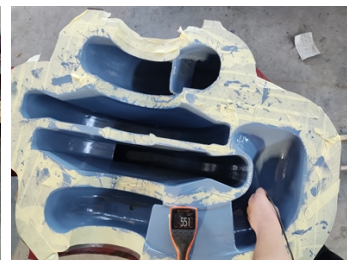
DFT after cured
