Pipe Strengthening with Belzona SuperWrap II

ID: 9330

Customer Location: Toronto, Ontario

Application: VPF-Valves, Pipes and Fittings

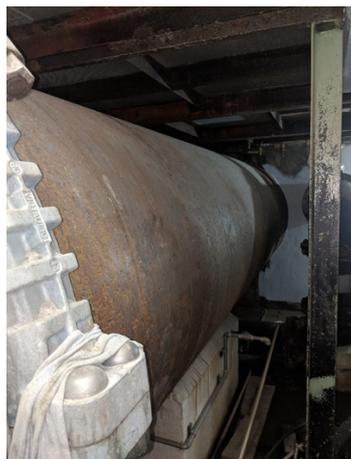
A 60" carbon steel pipe that had suffered from external corrosion and metal loss over the years. The defective area was about 15 feet. They required a solution that would reinstate the structural integrity of the pipe.

Corroded section of the pipe

We used ASME PCC2 equations to estimate the number of wraps required to retrofit the pipe to design conditions. The defect was type A (thin wall), corrosion was external, and the pressure was relatively low (25 psi). 2 wraps of Belzona SWII were recommended to structurally reinforce the pipe and effectively stop corrosion on the pipe. This repair system can remain maintenance-free for up to 20 years.

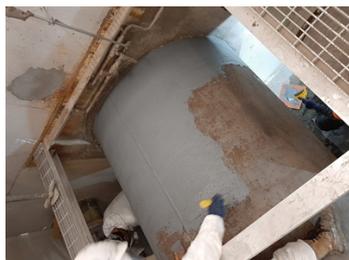
Application of Belzona 1121

First, the pipe was grit blasted and prepared according to SSPC SP10. All the pitting and resurfacing was then done with Belzona 1121(Super XL-Metal) because of its longer overcoating time. The next day, they started applying Belzona SWII. They applied the wrap in 4 feet sections at a time, so every 4 feet they would consolidate the repair with Belzona 9382 and continue with the next section. Though the application was during colder climate, Belzona 1982 was chosen to give more working life and allow the crew to complete the application properly.

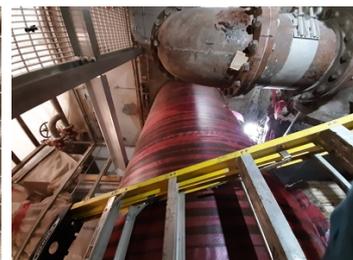
Wrap completed and consolidated with Belzona 9382

Customer received an ISO/ASME compliant repair system able to stop the corrosion, return the mechanical strength back to the water pipe and designed to provide a 20 year lifetime.
