Protection of elbows in municipality potable water plant

ID: 9336

Application: VPF-Valves, Pipes and Fittings

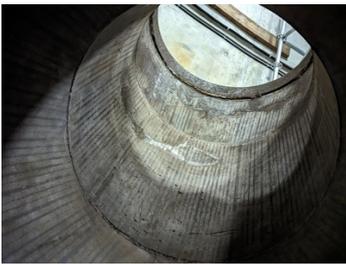
Pipe elbows had a concrete liner which was very deteriorated and at times concrete chunks became loose in the system which was unacceptable.

Elbow with deteriorating concrete liner.

The city had already planned a shutdown to address other equipment in the plant, so they decided to remove the concrete liner in the elbows and change it with a coating that was approved for potable water. The project was divided into 2 phases for a total of 6 elbows.

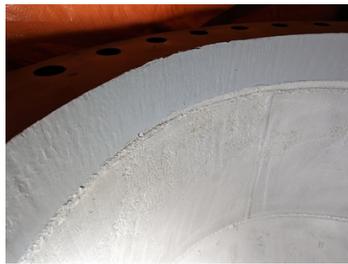
Rebuilding deep pitting with Belzona 1111.

All the elbows were grit blasted to SSPC SP10. They had pitting and irregular welds which were smoothed and filled with Belzona 1111. Then Belzona 1111 was frost blasted, stripe coated and two coats of Belzona 1341N were applied.

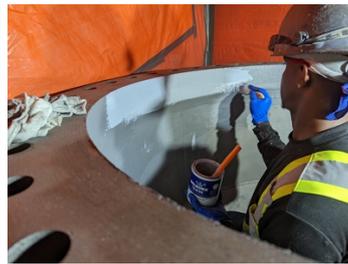
Application of stripe coats of Belzona 1341N.

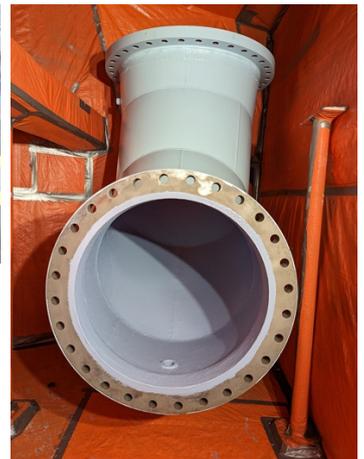
Elbow after application of second coat of Belzona 1341N.
