# Coated Secondary Containment Areas

ID: 9347

Industry:	Water / Wastewater	Customer Location:	Ontario
Application:	FPA-Floor Problem Areas	Application Date:	
Substrate:	Concrete		
Products:	Belzona 4311 (Magma CR1),Belzona 4911 (Magma TX Conditioner),Belzona 5811 (Immersion Grade),Belzona 9111 (Cleaner Degreaser)

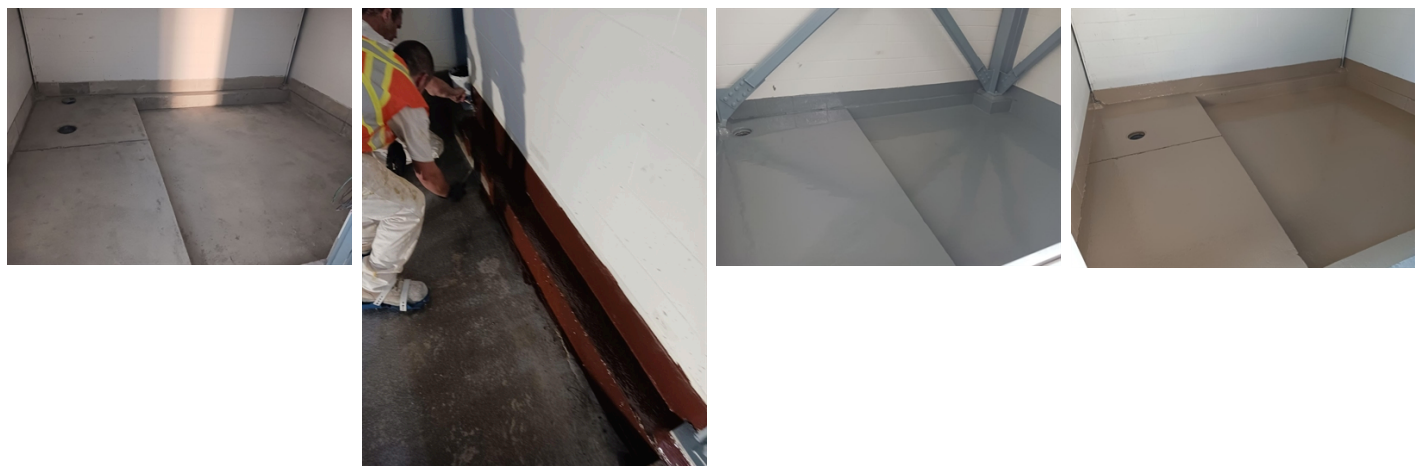
Preparation work completed

Application of first coat of Belzona 4311

Application Belzona 4311 completed

Application Belzona 5811 Completed

All concrete was ground using a grinder with a diamond Disc, all dust was vacuumed and area cleaned by using Belzona 9111, A mositsure test was performed to check the mositsure level content, it was below the 6% that is recommended. Three rooms required Belzona 4911 Magma Conditioner and Belzona 4311 Magma CR1 coating, the forth room required protection using Belzona 5811.
