# Protection of new Flygt Pump

ID: 9348

Industry: Other  
Application: PDP-Positive Displacement Pumps

Substrate: Cast Iron  
Products: Belzona 1321 (Ceramic S-Metal)

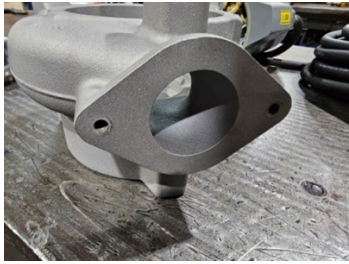
Pump after grit blasting.

Pump was grit blasted to standard SSPC SP5 and coated with Belzona 1321.
