# Protection of new Flygt Pump

ID: 9348

Industry: *Other*  
Application: *PDP-Positive Displacement Pumps*

Substrate: *Cast Iron*  
Products: *Belzona 1321 (Ceramic S-Metal)*

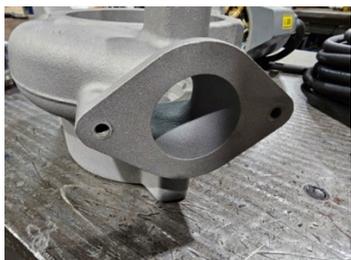
Pump after grit blasting.

Pump was grit blasted to standard SSPC SP5 and coated with Belzona 1321.

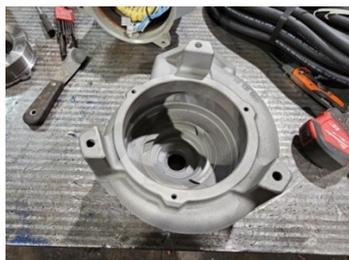
Casing after grit blasting

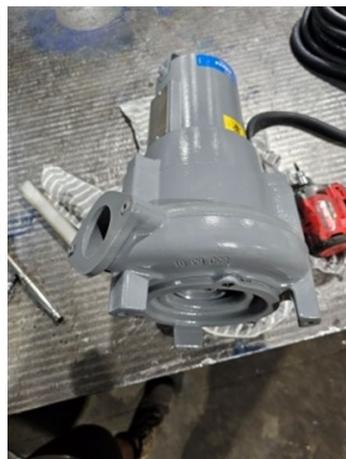
After application of Belzona.

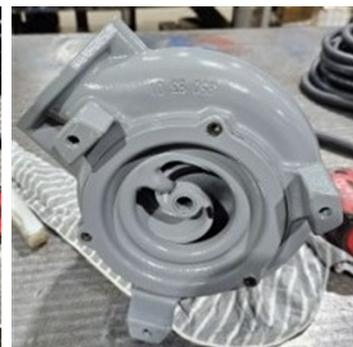
After application of Belzona.
