# Belzona protects newbuilt lift station tank in a marine vessel.

ID: 9349

Industry: *Marine*  
Application: *TCC-Tanks and Chemical Containment Areas*  
Substrate: *Other*  
Products: *Belzona 5892*

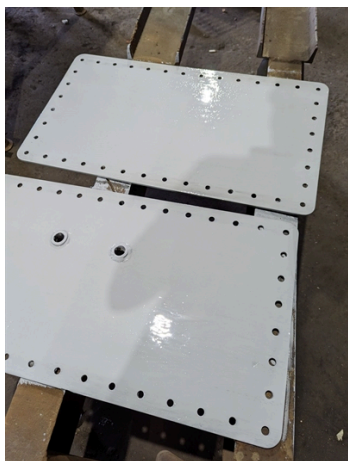
After application of Belzona 5892.

Power tool cleaning was done and two coats of Belzona 5892 was applied.

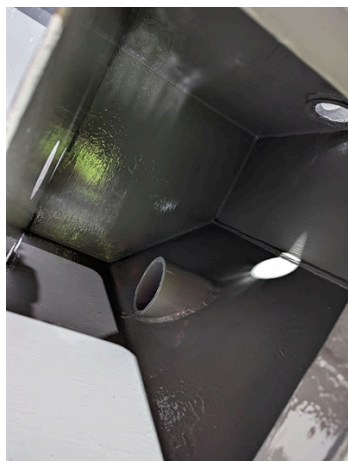
After application of Belzona 5892.

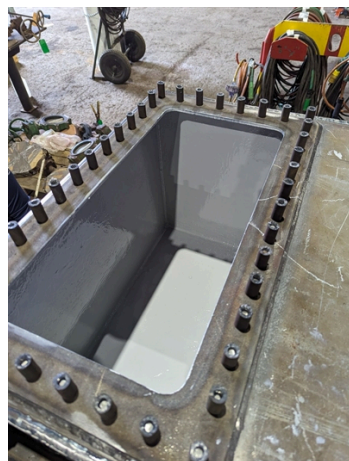
After application of Belzona 5892.

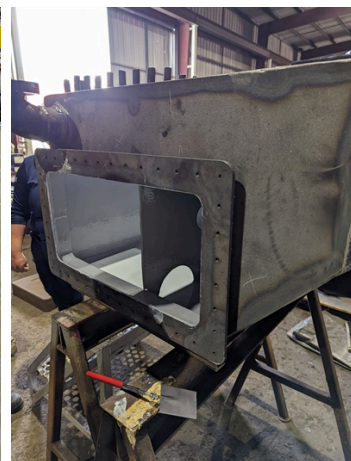
After application of Belzona 5892.
