# Cold bonding to repair leaky cooling tower

**Industry:** Heating, Ventilation & Air Conditioning  
**Application:** HEX-Heat Exchangers  
**Substrate:** Carbon steel  
**Products:** Belzona 1111 (Super Metal)

**Customer Location:** Kitchener  
**Application Date:** April 2019

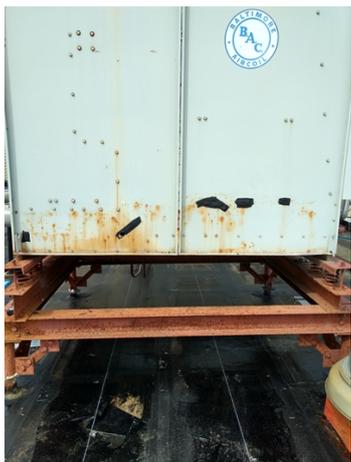
Customer was having problems with their cooling tower. The equipment was experiencing corrosion and in some areas they even had through wall defects.

Damaged cooling tower

The customer wanted to seal the holes in the equipment to prevent further deterioration. They did not want to weld as they knew that welding would require specialized equipment, hot work and post-welding treatment to revert metallurgical changes caused by welding. We showed the advantages of our Belzona cold bonding solution and the customer decided to proceed with it.

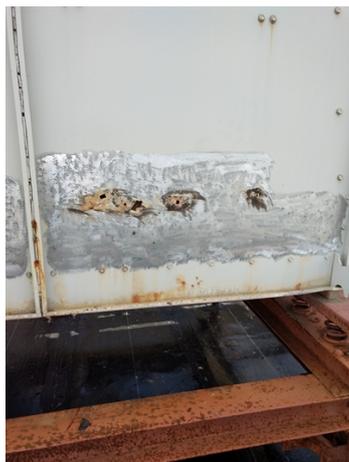
Surface preparation with a grinder over the affected area

Patch plates were pre-designed to fit the damaged area. The surface of the weakened substrate and underside of the plate were cleaned and abraded to create a mechanical profile. Belzona 1111 was mixed and applied over the damaged area and on the underside of patch plate, making sure the material was wetting out the profile as much as possible. The metal plate was then forced on to the weakened substrate. Excess material exuding from the edges was removed and chamfered around the perimeter of the plate.

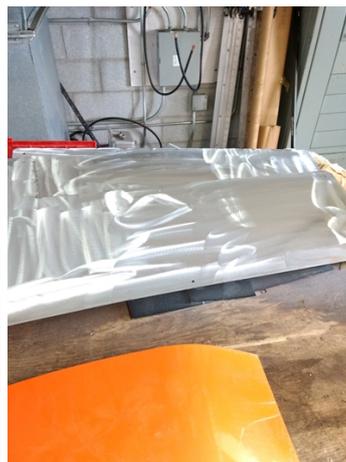
Surface preparation on the underside of the plate to be bonded

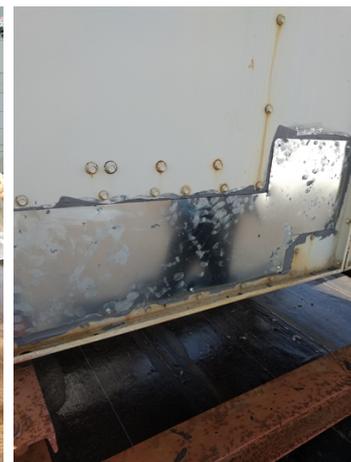
Complete repair

The repair was completed in a few hours with minimal disruption to the facility operations. The cold bonding solution is a robust repair and the customer can expect a long term repair out if this solution.
