BELZONA FACILITATES CHANGE OF USE

Industry: Oil & Gas
Application: VPF-Valves, Pipes and Fittings
Substrate: Carbon Steel
Products: * Belzona® 1341 (Supermetalglide) ,
* Belzona® 1111 (Super Metal) ,

Customer Location: Oil Production Platform North Sea
Application Date: March 2006

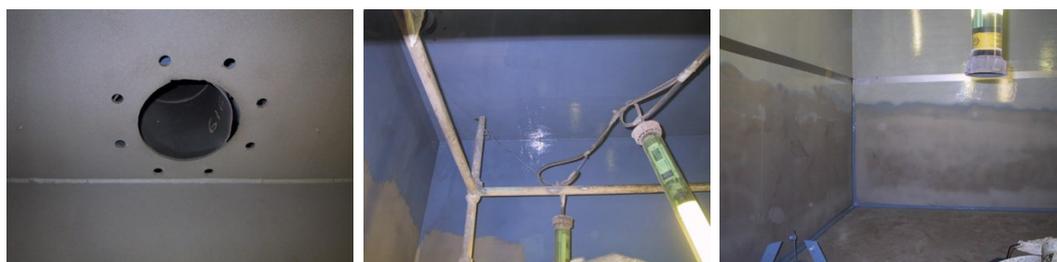
Photograph Descriptions

- * Top half of the vessel blasted ready to start coating ,
- * First coat of Belzona® 1341 being applied ,
- * Top half of the vessel coated with 2 coats Belzona® 1341, note masking tape in position for the reblasting of the bottom half of the vessel ,
- * Bottom half of the vessel with the first coat Belzona® 1341 applied ,

Application carried out in accordance with Belzona Know-How System Leaflets TCC-5 and VPF-13. All nozzles had Belzona inserts fitted and all the flange faces were formed with Belzona® 1111.
