One Day Turnaround for Belzona Floor Repair at Iron Ore Mine

Customer Location: Iron ore mine in South Africa

Application: FPA-Floor Problem Areas

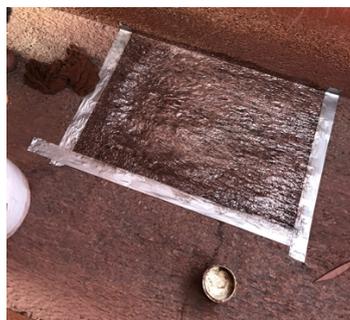
The customer was experiencing severe erosion on the floor area of a launder. This area was used for the transfer of water and slurry to the thickener dams where it is disposed of. The customer was unable to use the alternative which, in this case, was concrete as this meant the launders would be out of service for 28 days.

Smaller are prepared ready for Belzona application

Surface preparation was carried out by hand as the substrate was concrete with blue stone in it. Belzona 4911 (Magma TX Conditioner) was first applied to the area, and then Belzona 4131 (Magma-Screed) one metre at a time. Distributor's own application team carried it the application on site.

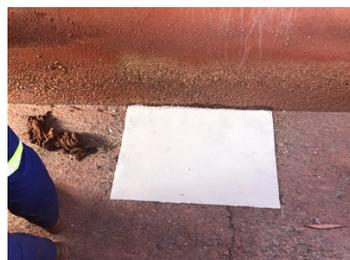
Belzona 4131 applied to damaged area.

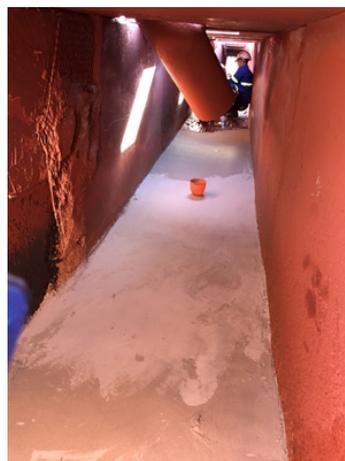
Application in progress

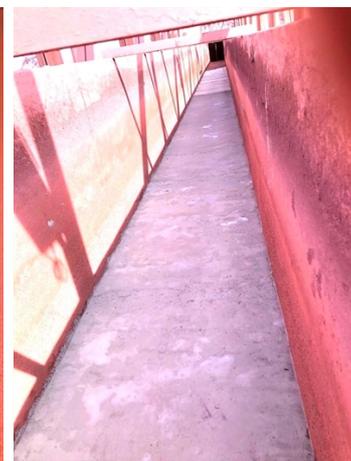
Completed repair with Belzona 4131 in service for 5 years

These initial repairs have been in service for 4-6 years and they show no signs of wear.
