Belzona Repair of Floating Marine Fuel Hoses

ID: 9384

Industry: Marine
Application: SOS-Ships and Offshore Structures

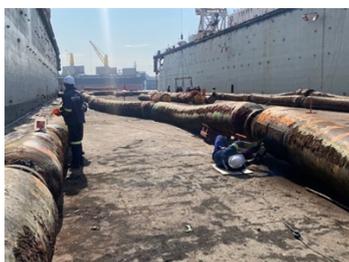
Hoses being prepared ready for Application in progress repair

Upon completion of surface preparation, a Belzona Elastomer conditioner was applied to all surfaces that the Belzona 2000 Series product was to be bonded on to. Belzona 2111, Belzona 2131 and Belzona 2211 incorporating Belzona 9341 were then used to repair the hoses.

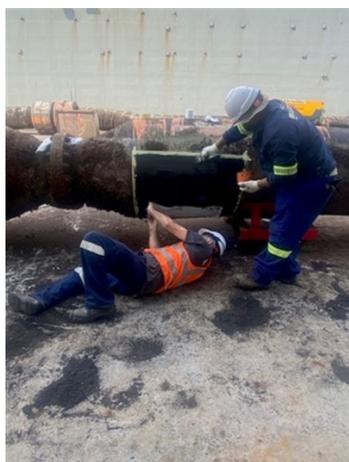
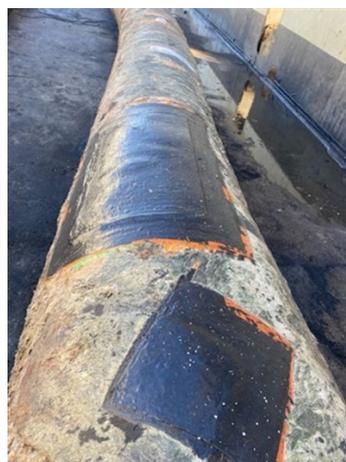
Repair area

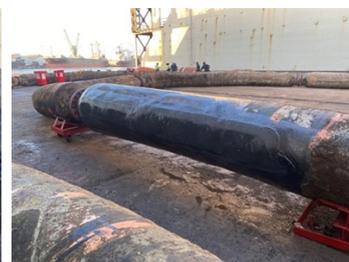
Example of a complete hose repair
