# Belzona Repair of Floating Marine Fuel Hoses

ID: 9384

Industry: Marine  
Application: SOS-Ships and Offshore Structures

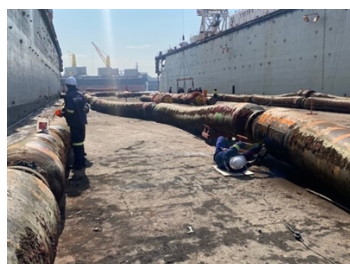
Hoses being prepared ready for Application in progress repair

Upon completion of surface preparation, a Belzona Elastomer conditioner was applied to all surfaces that the Belzona 2000 Series product was to be bonded on to. Belzona 2111, Belzona 2131 and Belzona 2211 incorporating Belzona 9341 were then used to repair the hoses.

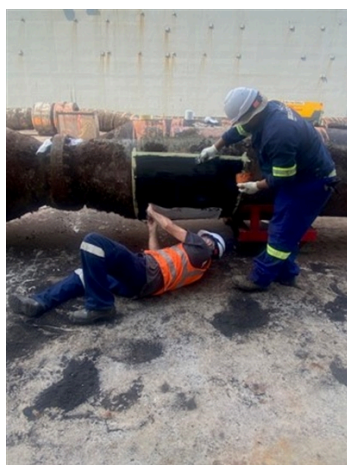
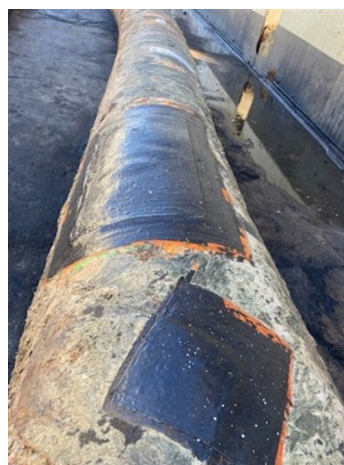
Repair area

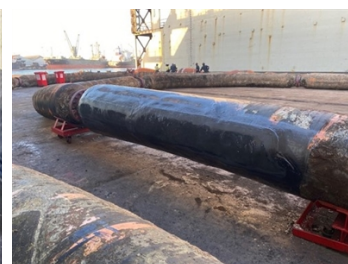
Example of a complete hose repair
