Belzona Roof Repair in Ore Mine

Industry: *Mining & Quarrying*
Application: *RPA-Roof Problem Areas*
Substrate: *Other*
Products: *Belzona 3111 (Flexible Membrane), Belzona 3911 (PSC Surface Conditioner)*

Customer Location: *Ore Mine in South Africa*
Application Date: *January 2020*

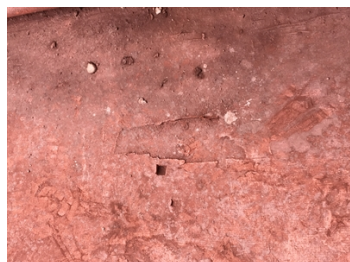
The old weather proofing systems had failed and there was water and dust entering these substation roof through the seams and joints.

Leaking roof area

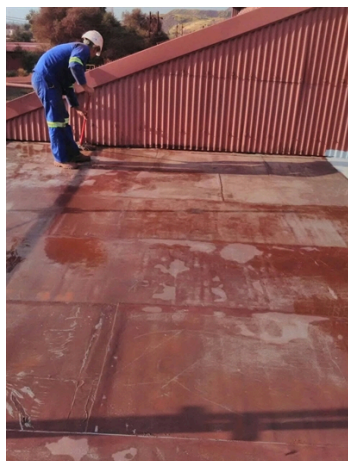
Surface preparation

The original coating was removed as it was loose. On completion of surface preparation including washing and degreasing, Belzona 3111 (Flexible Membrane) was used in conjunction with the Belzona 3911 (PSC Conditioner) and Belzona 9311 (Reinforcement Sheet). This facilitated swift waterproofing of the compromised roof sections. The application area was 150 square metres.

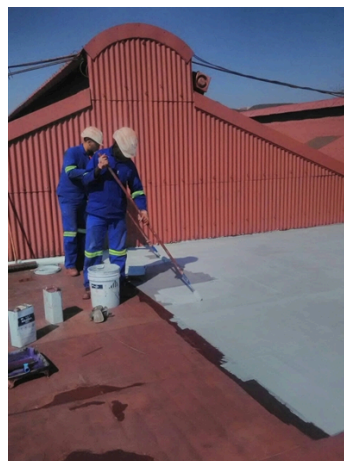
Application in progress

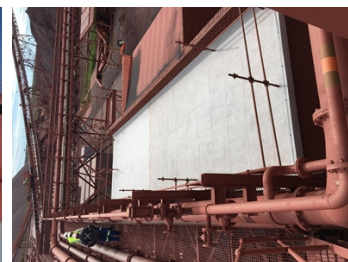
Another area being coated
