Cold Bonding with Belzona at Two Major Tank Farms

Industry: Chemical & Petrochemical
Application: TCC-Tanks and Chemical Containment Areas
Substrate: Carbon steel
Products: Belzona 1111 (Super Metal)

Customer Location: Netherlands
Application Date: January 2022

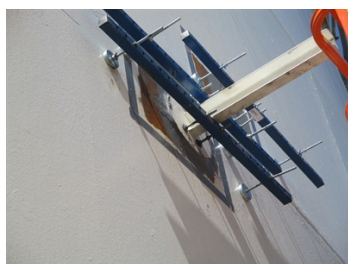
Brackets being bonded in place

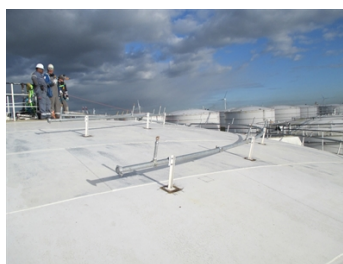
Brackets bonded in place
