# Repair of Holed Nozzles on a Vessel

**Industry:** Chemical & Petrochemical  
**Application:** VPF-Valves, Pipes and Fittings  
**Substrate:** Carbon steel  
**Products:** Belzona 1212, Belzona 5831 (ST-Barrier), Accessories

**Customer Location:** Melbourne, Australia  
**Application Date:** October 2023

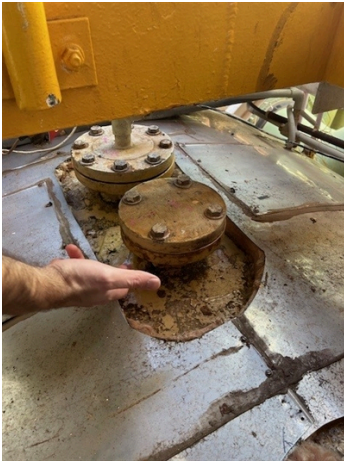
Customer had a process vessel containing a dangerous chemical during process which has faced severe corrosion at the nozzle joints.

Severe through wall corrosion at the base of the nozzles exposed dangerous chemicals during the process

Repair area, which was originally coated and corroded was ground and clean back to bare metal exposed the hole on the tank/nozzle.

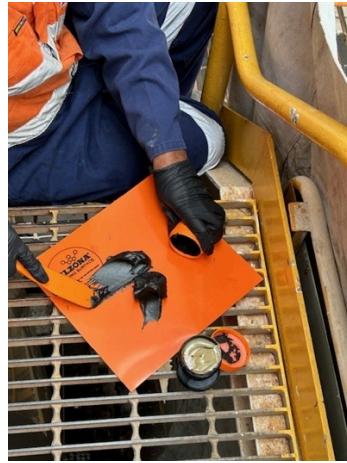
Mixing Belzona 1212 in preparation for the repair

Belzona 1212 was the product selected to bond and repair the area, due to inability to carry out any form of abrasive blasting.

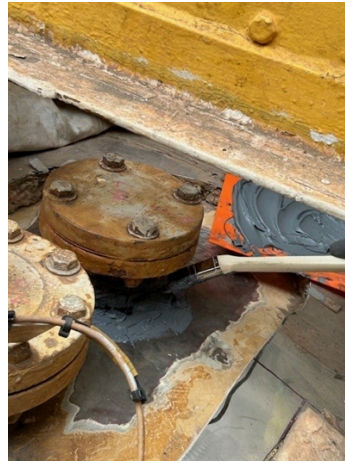
Application of Belzona 1212 over repair area with reinforcement plate/mesh to be fitted

Using reinforcement mesh and a metal mesh to cover the hole, the Belzona 1212 was applied in conjunction.

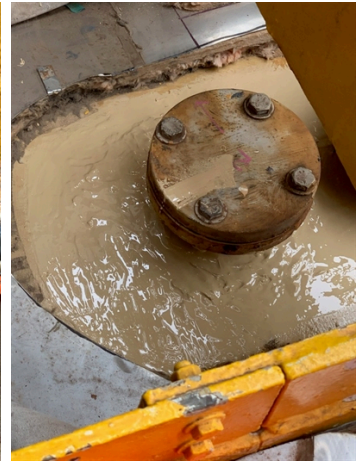
Completion of the application coated with Belzona 5831

Once cured, Belzona 5831 was applied to coat the repair area.
