Repair of Holed Nozzles on a Vessel

ID: 9390

Industry: Chemical & Petrochemical
Application: VPF-Valves, Pipes and Fittings
Substrate: Carbon steel
Products: Belzona 1212, Belzona 5831 (ST-Barrier), Accessories

Customer Location: Melbourne, Australia
Application Date: October 2023

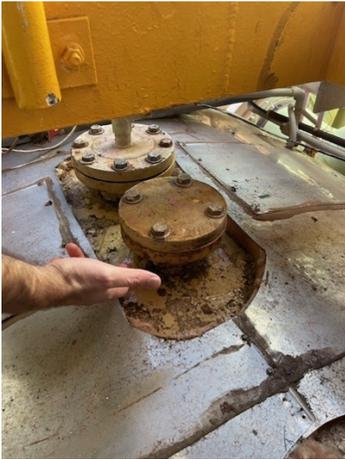
Customer had a process vessel containing a dangerous chemical during process which has faced severe corrosion at the nozzle joints.

Severe through wall corrosion at the base of the nozzles exposed dangerous chemicals during the process

Repair area, which was originally coated and corroded was ground and clean back to bare metal exposed the hole on the tank/nozzle.

Belzona 1212 was the product selected to bond and repair the area, due to inability to carry out any form of abrasive blasting.

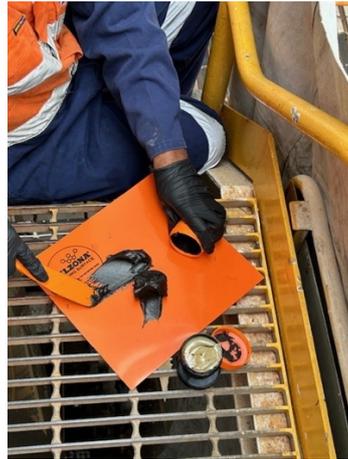
Mixing Belzona 1212 in preparation for the repair

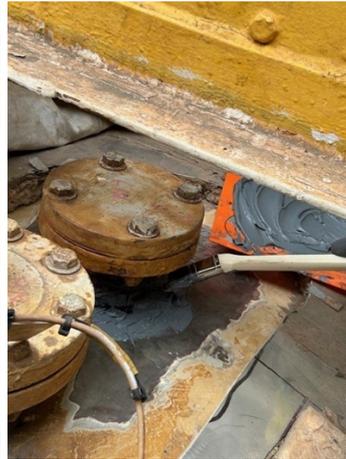
Application of Belzona 1212 over repair area with reinforcement plate/mesh to be fitted

Using reinforcement mesh and a metal mesh to cover the hole, the Belzona 1212 was applied in conjunction.

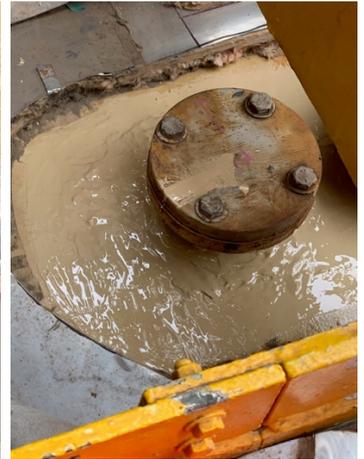
Completion of the application coated with Belzona 5831

Once cured, Belzona 5831 was applied to coat the repair area.
