Belzona 4311 on Chemical containment Area

ID: 9399

Industry: Power
Application: TCC-Tanks and Chemical Containment Areas
Substrate: Concrete
Products: Belzona 4311 (Magma CR1), Belzona 5811 (Immersion Grade)

Customer Location: Oklahoma
Application Date: May 2024

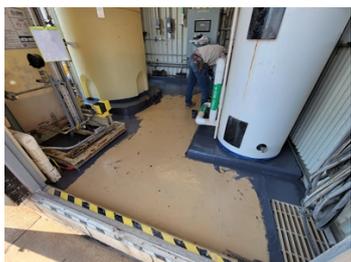
Beginning of the application

The floor was hand propped with angel grinders and diamond tip blades. After that it was cleaned and a first back coat was applied of Belzona 5811. After it was cured a two coat system was applied of Belzona 4311 gray and red.

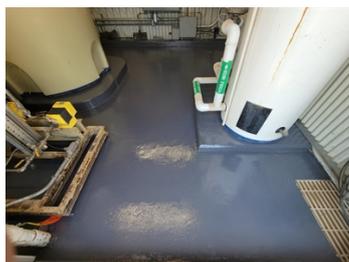
Application of first coat of Belzona 4311 gray

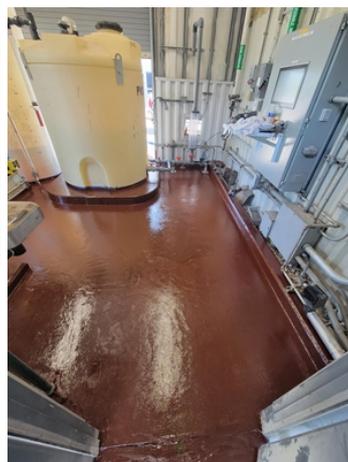
Application of second coat of Belzona 4311 red

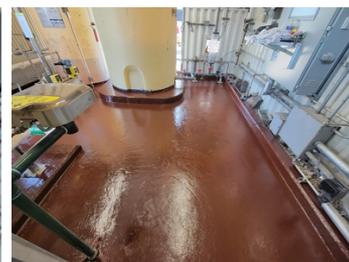
Application complete
