Belzona Seal-A-Tank to the rescue

ID: 9408

Application: TCC-Tanks and Chemical Containment Areas

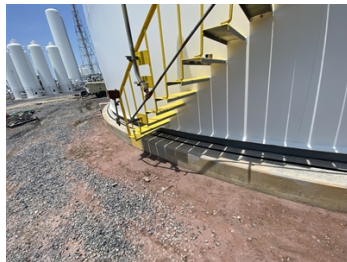
Blasting was being performed to prepare the carbon steel on the tank and the concrete for product application.

The tank and concrete were blasted for preparation. Then the area was cleaned. After that 3921 conditioner was applied. After this 3111 in conjunction with 9311 was applied to complete the Seal-A-Tank application.
