Belzona Seal-A-Tank to the rescue

ID: 9408

Industry: Chemical & Petrochemical
Application: TCC-Tanks and Chemical Containment Areas
Substrate: Carbon steel
Products: Belzona 3111 (Flexible Membrane), Belzona 3921 (GSC Surface Conditioner)

Customer Location: Geismar, LA
Application Date: May 2024

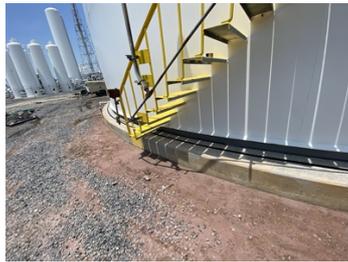
Blasting was being performed to prepare the carbon steel on the tank and the concrete for product application.

The tank and concrete were blasted for preparation. Then the area was cleaned. After that 3921 conditioner was applied. After this 3111 in conjunction with 9311 was applied to complete the Seal-A-Tank application.

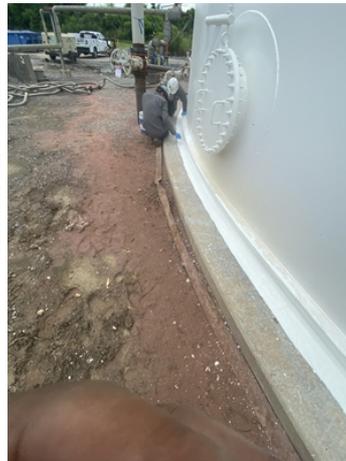
Blasting had been completed. Cleanup was done then conditioner applied to prepare for product application.

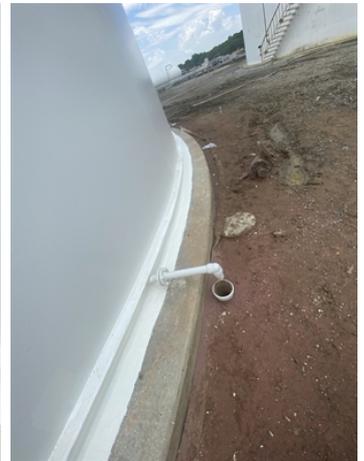
3111 with 9311 reinforcement cloth being applied to the tank and concrete.
