Accurate alignment of machinery

ID: 9422

Industry: Pulp & Paper
Application: GSS-Gaskets, Seals and Shims
Substrate: Concrete
Products: Belzona 5811 (Immersion Grade)

Customer Location: Vranov Slovakia
Application Date: October 2016

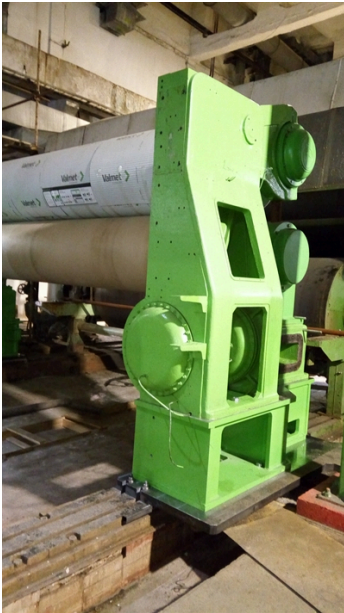
Stability of the device after its installation in operation.

A device that needed to be stabilized.

Height adjustment of all surfaces.

The application of Belzona 5811 .

The application of Belzona 5811 composite was carried out using pressurized injection cartridges. This allowing a quick application and return to service.

Undercoating with Belzona 5811 was faster and cheaper than using construction mortars.
