BELZONA WEATHERPROOFS BALCONY

ID: 943

Customer Location: Housing Association, Merseyside, UK
Application Date: February 2007

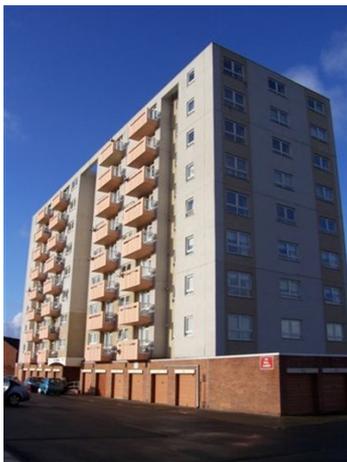
- * 1. One of the three blocks of flat ,
- * 2. Loose asphalt being removed ,
- * 3. Belzona 3131 being applied ,
- * 4. Aggregate being scattered onto top coat of Belzona 3131 ,
