# BELZONA 3412 FLANGE PROTECTION SYSTEM

ID: 9431

Customer Location: EDF ENERGY HEYSHAM LANCASHIRE  
Application Date: June 2024

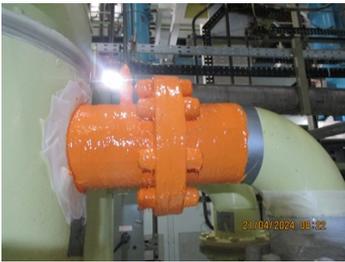
FLANGE & FASTENINGS PROTECTION

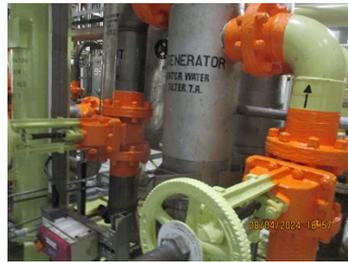
2 X COAT SYSTEM OF BELZONA 3412 PROTECTING FLANGE GASKET AREAS AND FASTENINGS.

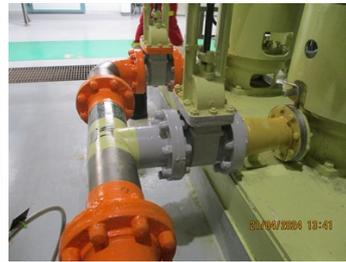
MULTIPLE FLANGES SHOWING FIRST & FINAL COAT APPLICATIONS.

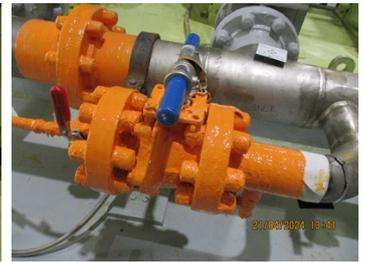
BELZONA 3412 CAN BE APPLIED TO ALL GEOMETRIES AND SEAL THE FLANGE AND FASTENINGS, EASY INSPECTION AND RESEAL.
