Belzona SuperWrap application on ammonia pipes

ID: 9441

Industry: Chemical & Petrochemical
Application: VPF-Valves, Pipes and Fittings
Substrate: Carbon steel
Products: Belzona 1121 (Super XL-Metal), Belzona 1982 (SuperWrap II), Belzona 5811 (Immersion Grade)

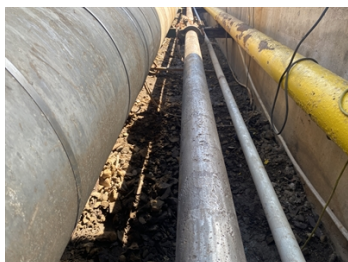
Belzona Superwrap II structural reinforcement system, under ASME PCC-2 standard, for 20 meters of buried pipe. This particular pipe was carrying ammonia. The pipe was experiencing pitting and wear and tear.

Corroded pipe used to carry ammonia.

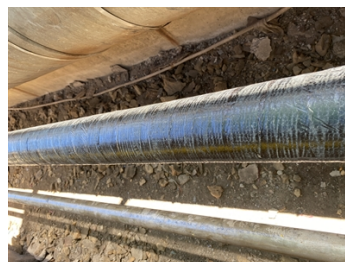
The pipe is encapsulated with Belzona SuperWrap II.

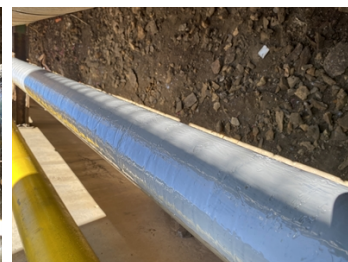
The repaired pipe overcoated with Belzona 5811
