Belzona SuperWrap application on ammonia pipes

ID: 9441

Industry: Chemical & Petrochemical
Application: VPF-Valves, Pipes and Fittings
Substrate: Carbon steel
Products: Belzona 1121 (Super XL-Metal), Belzona 1982 (SuperWrap II), Belzona 5811 (Immersion Grade)

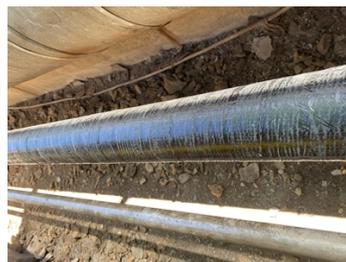
The pipe is encapsulated with Belzona SuperWrap II.

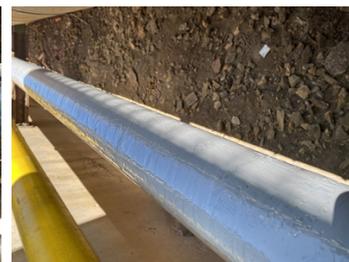
The repaired pipe overcoated with Belzona 5811
