Belzona 4311 Protects Chemical Containments

Industry: Power
Application: TCC-Tanks and Chemical Containment Areas
Substrate: Concrete
Products: Belzona 4111 (Magma-Quartz), Belzona 4311 (Magma CR1), Belzona 4361

Customer Location: Jasper, AL
Application Date: November 2023

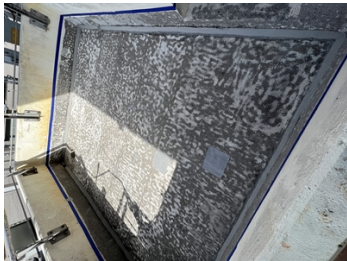
Sandblasted (3) containment areas

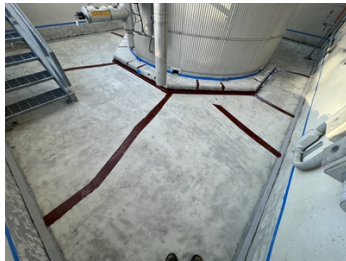
Addressed Cracks and Seams with Belzona 4361 and composite tape

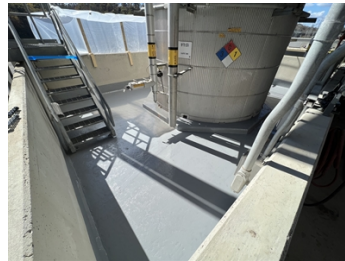
Applied (1) coat of Belzona 5811

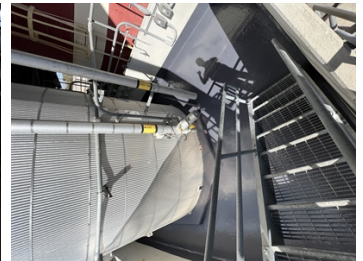
Applied 1 final Coat of Belzona 4311
