# BELZONA SUCESSFULLY RENOVATES PUDDLE PIPES

**Industry:** Power  
**Application:** VPF-Valves, Pipes and Fittings  
**Substrate:** Mild steel  
**Products:** \* Belzona® 1311 (Ceramic R Metal) ,  
\* Belzona® 1321 (Ceramic S Metal) ,

**Customer Location:** Nuclear Power Station, UK  
**Application Date:** Summer 2006

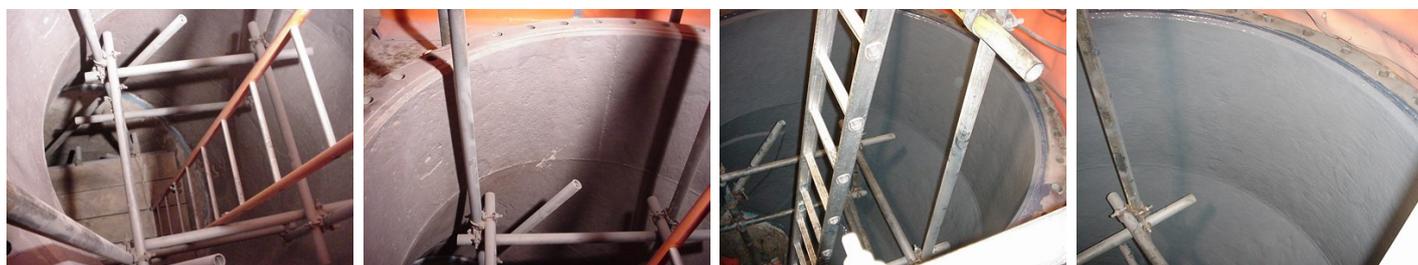
Corrosion affects these pipes where the concrete pipe in the sea connects with the steel pipe into the power station and the previous ceramic based products had failed to give the level of protection that was needed. Very regular coating was needed to keep the situation under control.

- \* Scope of work ,
- \* Grit blasted ready for application ,
- \* Top section complete ,
- \* The finished surface and joint line ,

Corrosion on seawater inlet pipe to cooling system for nuclear power station.

Application carried out in accordance with Belzona System Leaflets VPF-1 and VPF-2. A 4-coat system was adopted by the power station to maximise longevity.

Trials were carried out at another power station with Belzona system pitted against two alternative suppliers (both ceramic based products). Belzona was found to be the clear winner when it came to erosion corrosion protection and therefore best value for money. Full life expectancy has yet to be determined. Due to location, full inspection is not appropriate but recent CCTV images

show no corrosion to date. It is anticipated that the coating will give excellent performance for at least six years as opposed to previous recoating which was carried out every two years.
