Belzona Gives The Roller Traction

ID: 9492

Application: *SHM-Solids Handling Machinery*

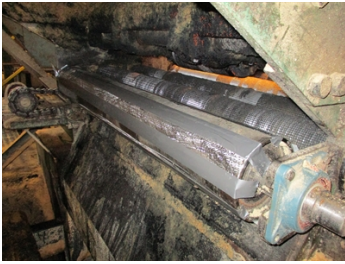
The roller with four sections taped off and hand ground, solvent washed and ready for application.

A 4" hand grinder was used to heavily roughen the surface where the application was going to be. The area was thoroughly washed with solvent, and the Belzona 1321 was applied in one heavy coat about 15-20 mils thick before having the Belzona 9221 aggregate sprinkled into it and gently packed down with a small board.

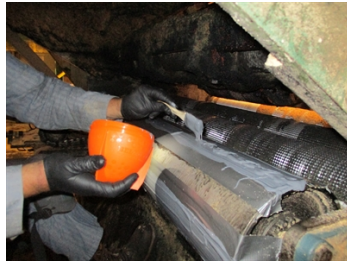
Applying a heavy layer of Belzona 1321 to the application zone before liberally sprinkling Belzona 9221 aggregate into it.

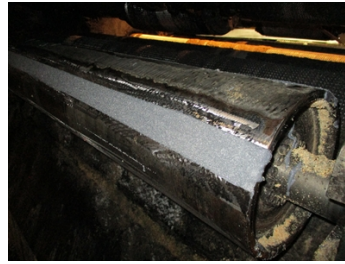
Belzona 9221 aggregate sprinkled into the Belzona 1321 to refusal and packed down.

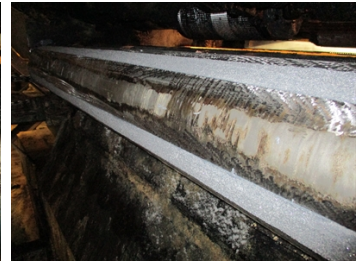
Application complete.

This drive roller was smooth which made it hard to move lumber with it. The customer chose to apply four strips of Belzona 1321 embedded with Belzona 9221 aggregate for positive grip. This allowed the lumber mill to be able to slow down the drive motor and reduce the cost of operation.
