# Belzona Super Wrap II Extends Service Life of Water Injection Holding Tank

ID: 9498

Industry: Oil & Gas  
Application: SOS-Ships and Offshore Structures

Customer Location: Gulf Of Mexico  
Application Date: June 2024

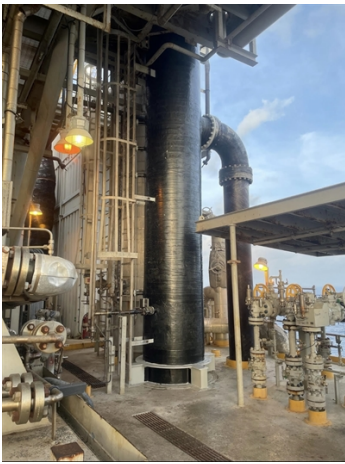
This water injection holding tank was suffering from internal corrosion causing thin wall throughout the entire vessel. The customer was looking for a life extension instead of a costly cut and replace.

Completed Application In Service

This customer was looking for a life extension to the vessel rather than a costly cut and replace. A cut and replace was going to be roughly \$600,000. This customer uses Belzona Super Wrap II on a routine basis for addressing through wall holes and thin wall in process piping and vessels. They approached Belzona Houston / Belzona Offshore with the request and a Super Wrap II engineered design was developed and proposed to the client and after several meetings to discuss risks and benefits versus a cut and replace, the client choose to execute the Belzona Super Wrap II. The Belzona Super Wrap II application was carried out by the trained and experienced onboard crews which routinely utilize Belzona Super Wrap II. The client was able to execute this Belzona Super Wrap II life extension for under \$300,000, for a cost savings of \$300,000 along with reduced downtime compared to the cut and replace.

Scaffolding was erected and abrasive blast was used for surface preparation.
